**National Highway
Traffic Safety
Administration**

Case Vehicle (A): 1999 GMC
 Type: Suburban SLT 4 x 4, 4-door SUV
 Driver: 36-year-old female
 CDC: 03-RFEW-4

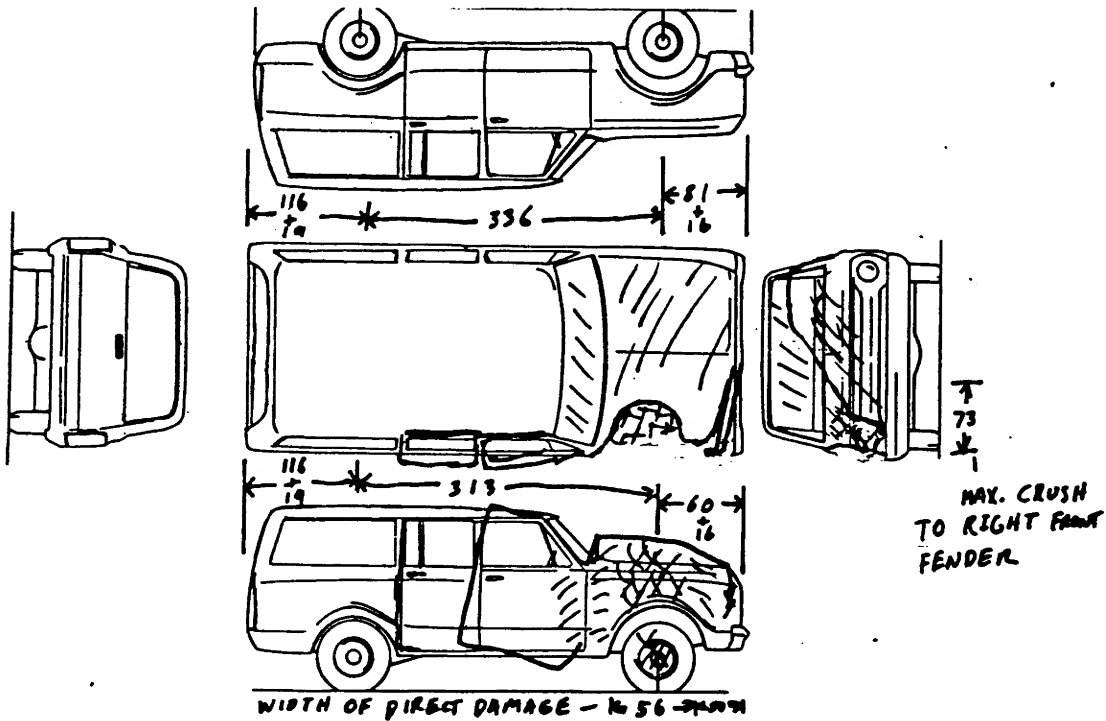
VEHICLE DAMAGE

Specific Impact No.	Location of Direct Damage	Location of Field L
1	begin 50 cm rear of Rt. f. BL	223 cm rear of Rt. f. BL
		Begin Rt. f. BL

Specific Impact Number	Plane of Impact C-Measur.	Direct Damage		Field L	C ₁	C ₂	C ₃	C ₄	C ₅	C ₆	±D
		Length (DDL)	Max Crush								
1	4	56	95	223	0	8	31	95	68	31	+135
	Free space				-1	-1	-1	0	0	6	
	stand adjustment		-22		-22	-22	-22	-22	-22	-22	
1	4	056	073	223	000	000	008	073	046	003	+135
13	14	15 16 17	18 19 20	21 22 23	24 25 26	27 28 29	30 31 32	33 34 35	36 37 38	39 40 41	42 43 44 45
2

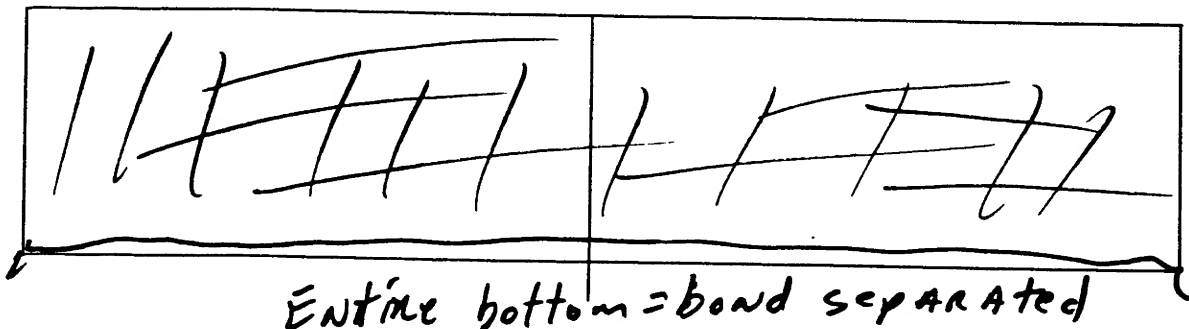
LOCATE AREA OF WINDSHIELD INTEREST OR DAMAGE WITH DIMENSIONS (VERTICAL & HORIZONTAL) ON THIS DIAGRAM OF THE WINDSHIELD AS VIEWED FROM INSIDE.

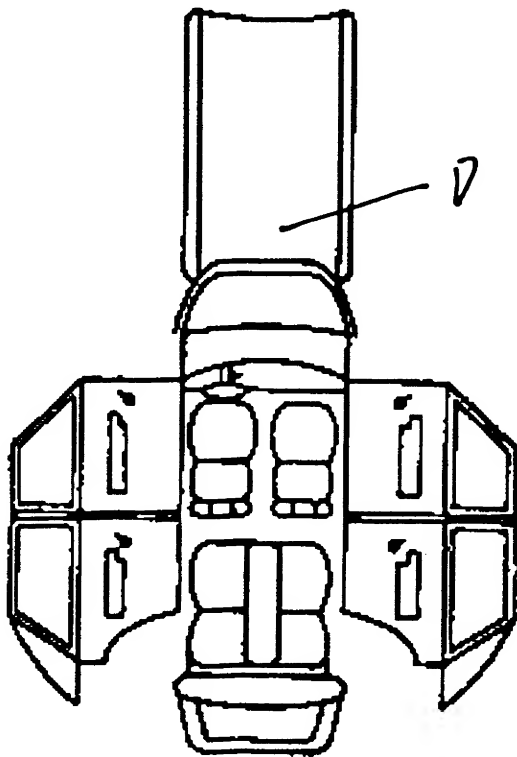
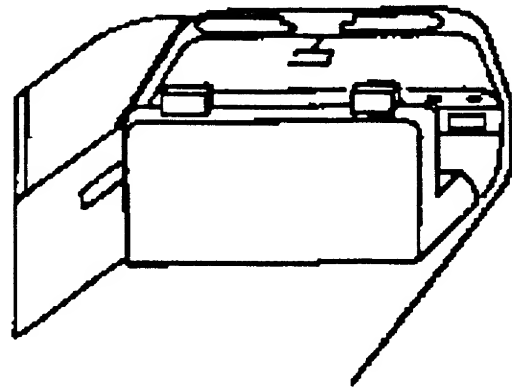
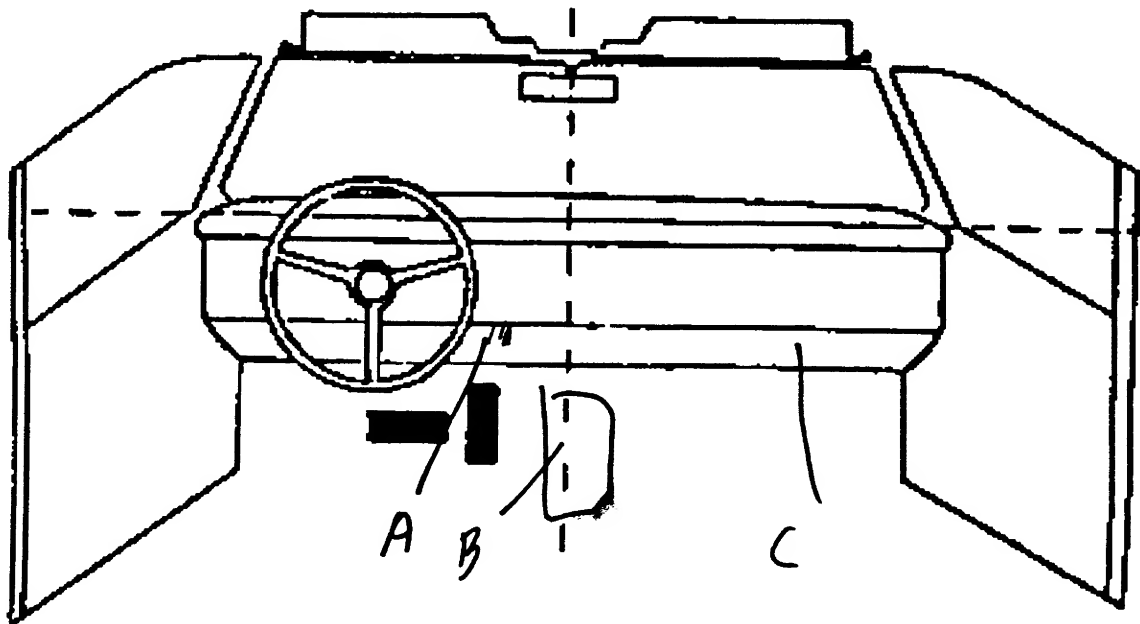
VEHICLE OCCUPANT CONTACT DIAGRAM

Contact	Interior Component Contacted	Occupant No. if Known	Body Region if Known	Supporting Physical Evidence	Confidence Level of Contact Point
A	KNAP BOLSTER	DA	Rt. Leg	Scuff	1
B	CENTER CONSOLE	DA	Legs or Buttocks	Scuff	1
C	GLOVE BOX	RF	Legs	Scuff	2
D	Roof	DA	Head	Scuff	1
E					
F					
G					
H					
I					
J

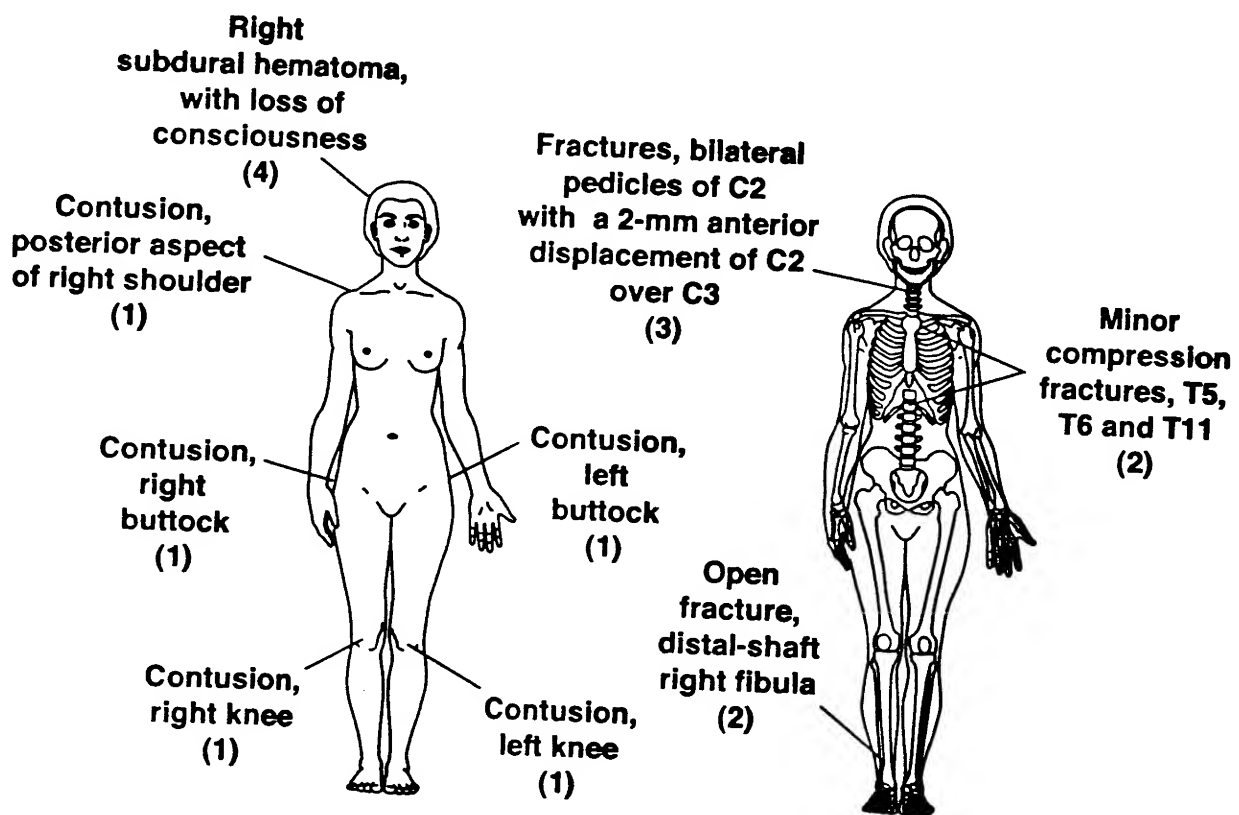
INDICATE LOCATION OF INJURIES.

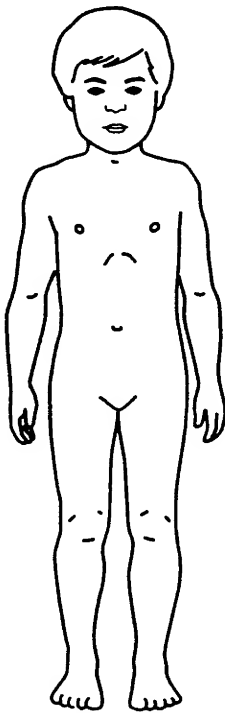
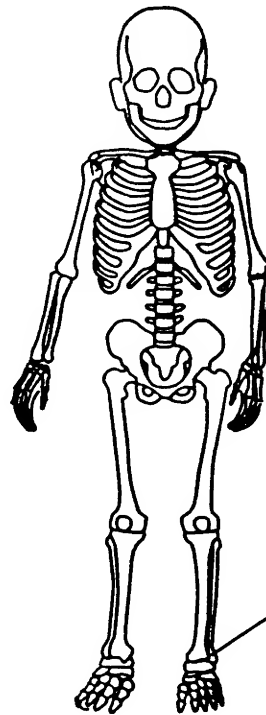
INDICATE LOCATION OF INJURIES.

Hairline fracture,
distal
left fibula
(2)

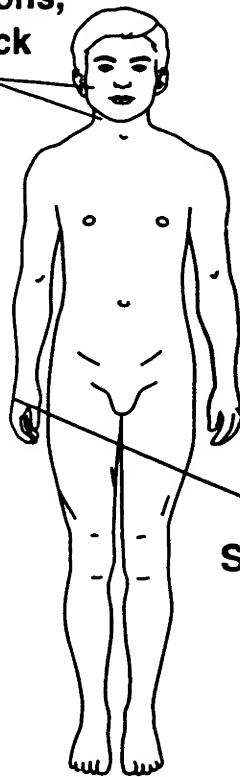
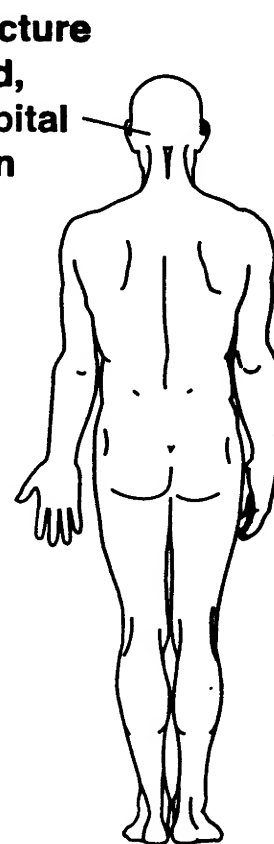
INDICATE LOCATION OF INJURIES.

Small lacerations,
face and neck
(1)

Small lacerations,
both hands
(1)

Small puncture
wound,
left occipital
region
(1)
